REPORT NO. 90-R-03  
AFPEA PROJECT NO. 90-P-107

Transportable Collective Protection System (TCPS)

15 August 1990

**Title:** Transportable Collective Protection System (TCPS) Testing

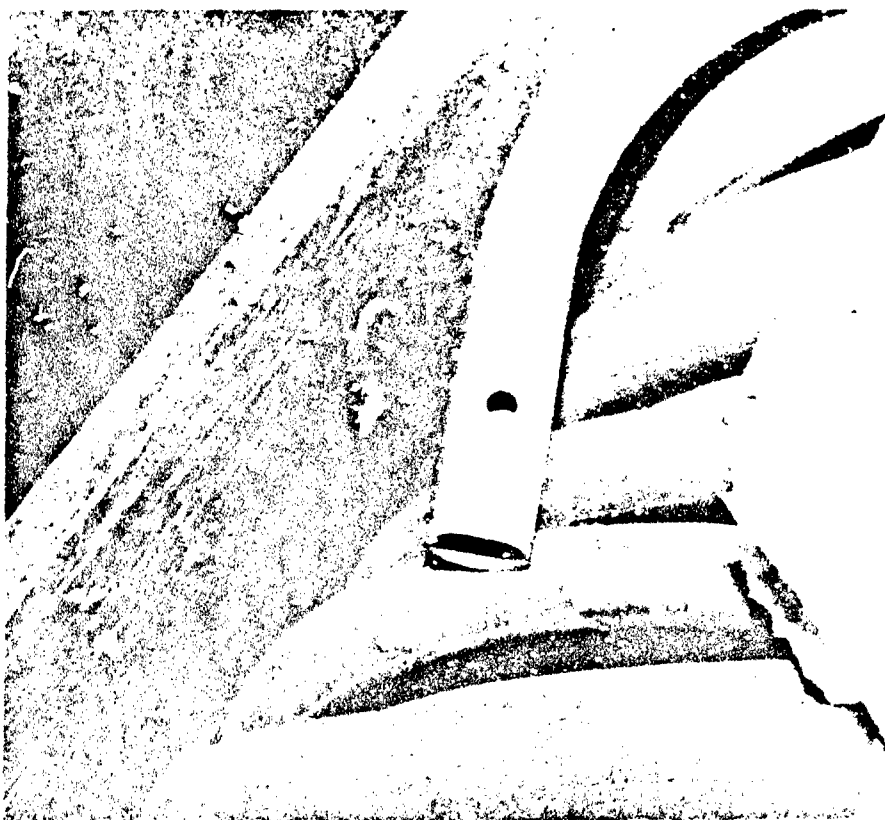
RESULTS: S/A Container was visually inspected after each test (see fig. 3). Only damage to container was one lost clip (see fig. 4). Minor damage was sustained by the TCPS unit. Aluminum support poles for the unit were damaged. Steel hose clamps (fastened to the aluminum support poles) ground into adjacent poles. Ends of poles also ground into adjacent poles. Ends of poles gouged inside walls of the container (see figs. 5 & 6). No other damage was observed. Functional equipment check was conducted by ILC/Dover at their facility in Frederic, DE.. Test results were not available for this report. S/A Container met all requirements of the test.

Fig 6  
Gouging of Container

CONCLUSIONS: Upon completion of AFPEA's evaluation, the three Rowley containers met all the requirements of HSD/YAGD and ILC/Dover Inc.. The S/A Container requires some modifications to restrain the aluminum support poles from grinding into each other and gouging the inside walls of the container. When modifications are complete, AFPEA will retest the S/A container in accordance with FTMS 101, Method 5019.1, Vibration (Repetitive Shock) Test.

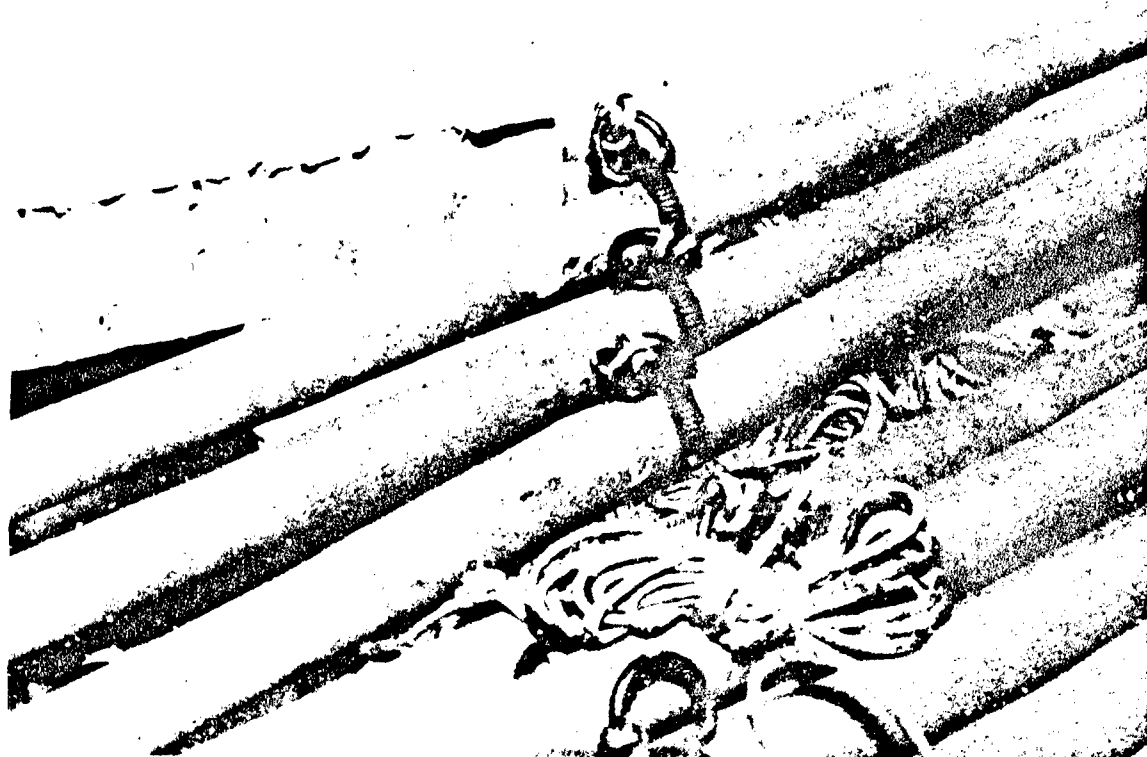
Fig 5  
Grinding of Adjacent Pipes
